New Jersey Water Environment Association Presents

SESSION II - Collection System O&M Sweet Solutions for Your Assets, Without Sugar Coating It!

**YANTACAW STREET
PARSHALL FLUME
WHY WE DIDN'T (SUGAR) COAT IT**

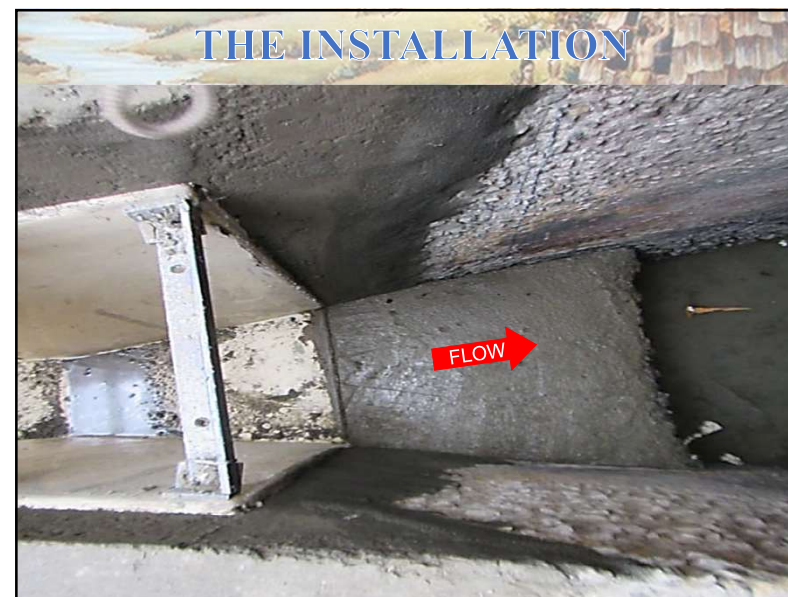
- This 1ft Parshall Flume was constructed of concrete in the early 1980's. The surface has eroded to the point where aggregate is exposed in the channel and the surface is no longer smooth as required for accurate flow measurement. In recent years, the flow range has been scaled down to match the modern flow conditions which varies between 0.6 and 1.2 MGD. (See Chart)
- **In lieu of resurfacing, it is recommended that PVSC consider nesting a 9" fiberglass flume which meets the current flow needs and will deliver a more accurate and reliable flow.**
- Since the existing open grating and rubber mats contribute to the water entering the chamber from the surface, please consider replacing them with Bilco doors to mitigate rainwater's effect on the erosion and odors from the chamber.
