NJWEA - Winter Tech Transfer 2025 Trenchless Technologies

Cleaning and Inspection Before
and After Rehabilitation
NJWEA Tech Transfer Winter 2025

Walter Jenness
Tri State
Environmental Services

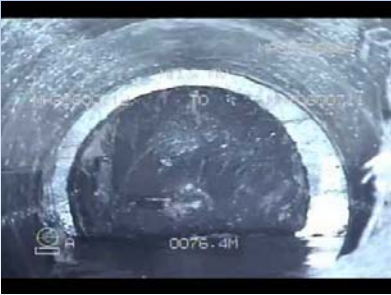
Roots

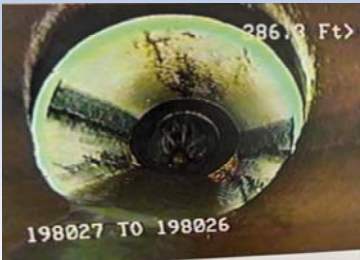
Pipe Repair

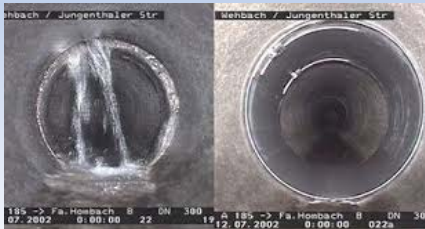
Stop Water prior to lining

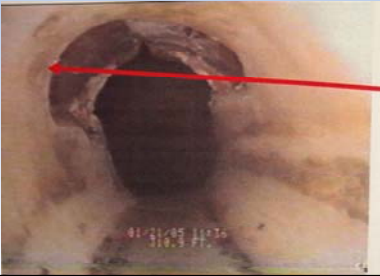
Defective Liner End- Liner cut out in Manhole
and withdrawn in line

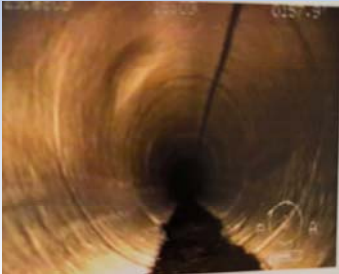
Abandoned Service or Missed Service

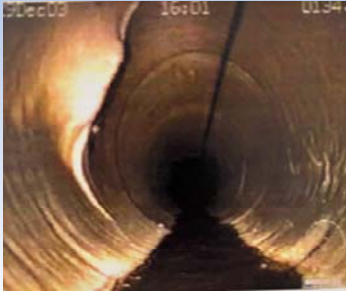
Bulge In Liner- host pipe may have protruding tap- broken piece host pipe

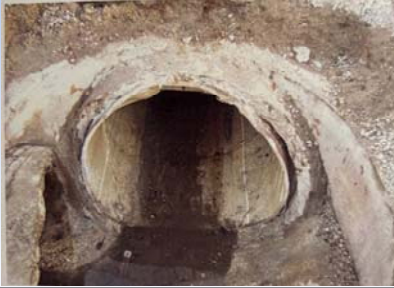
Annular Space Liner- Visible space – not closely fit
