NJWEA - Winter Tech Transfer 2026 Cleaning and Inspection

Cleaning the Right Pipe at the Right Time Using Acoustics

Sewer Line Rapid Assessment Tool

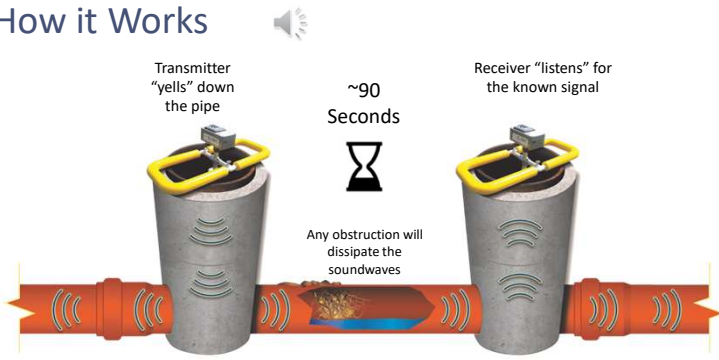
How it Works

Transmitter "yells" down the pipe

Receiver "listens" for the known signal

~90 Seconds

Any obstruction will dissipate the soundwaves

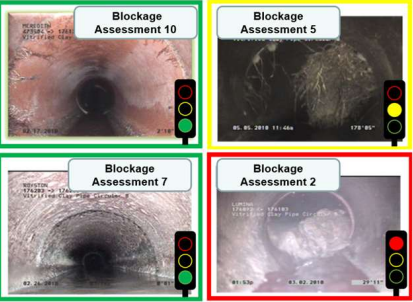
Scoring and Visual Comparison

Excess Flow

- Small root fibers
- Limited grease build up

6

- Roots and/or grease
- Robot can pass through

3

- Significant root intrusion
- Grease buildup
- Robot cannot pass through

Obstructed

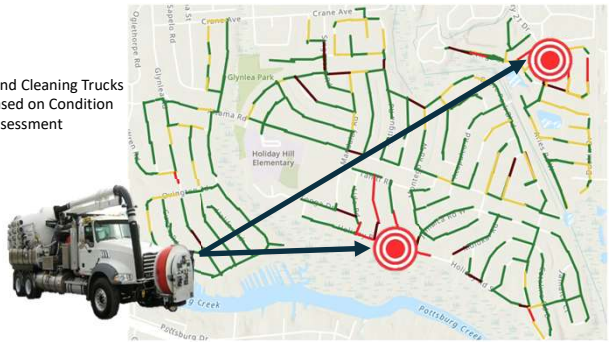
Condition-Based Maintenance

Send Cleaning Trucks Based on Condition Assessment

Real SL-DOG Data from JEA, Florida

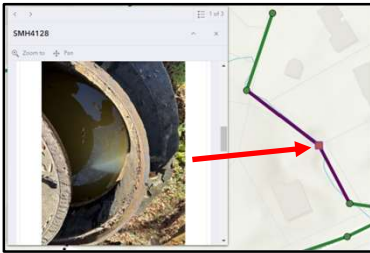
A surcharged manhole results in a score of 0

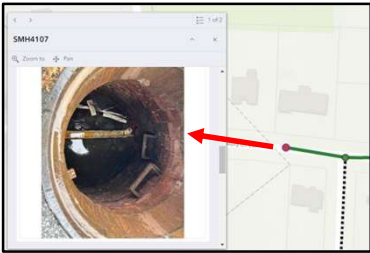
Debris in manhole but no flow impact

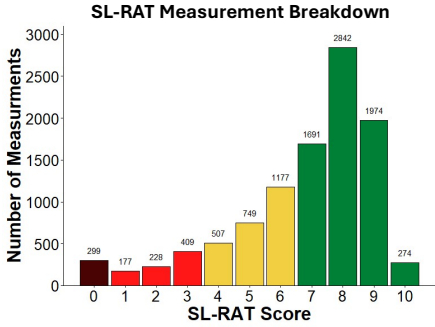
Green Bay SL-RAT Histogram

Footage	Percent
Segment Cleaned (0-6)	30k	23%
No Cleaning Needed (7-10)	221k	77%
