## PVSC Decant Tanks

# NJWEA - Fall Tech Transfer 2025 Trenchless Technologies

Decant Tank 6

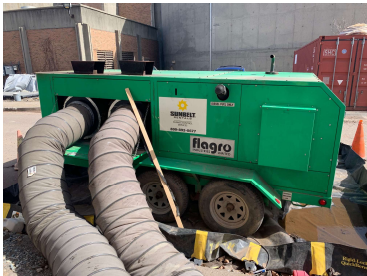
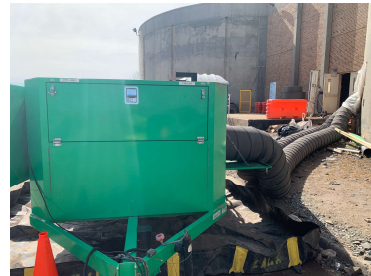
March 2022 – Heat Required

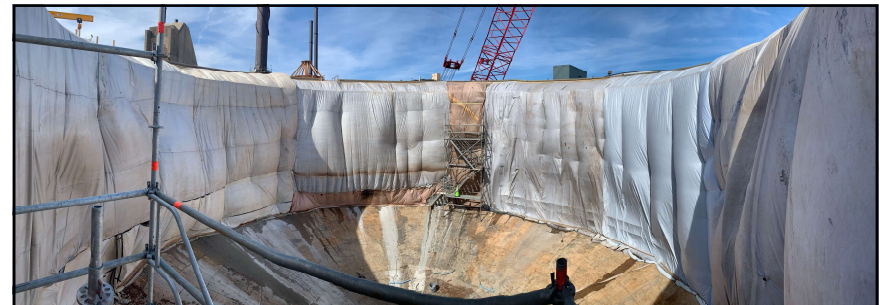
Tarped Area

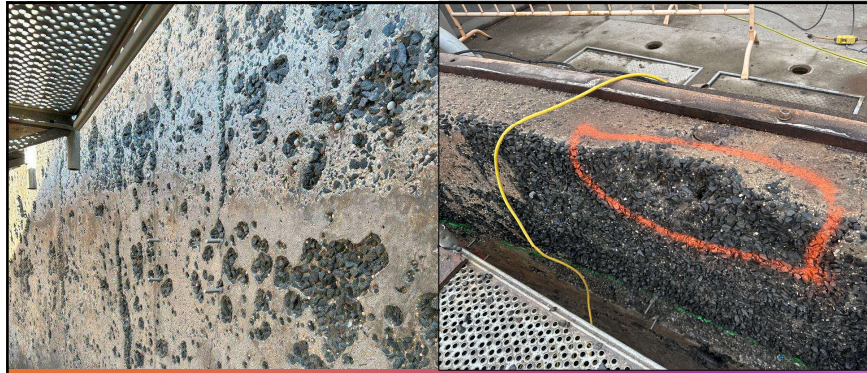
Decant Tank 3 – Larger Repair Pockets

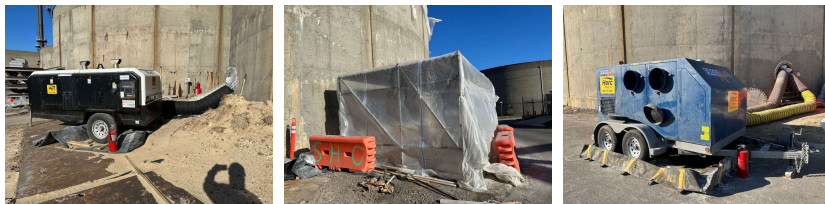
## Maintain Temperatures

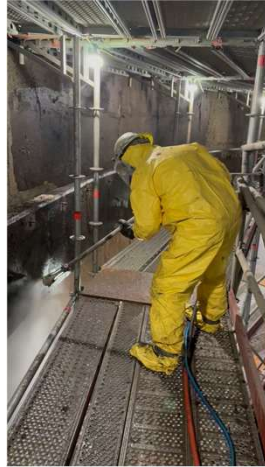
Starting Decant Tank 3
