NJWEA - Winter Tech Transfer 2026 Cleaning and Inspection

NJWEA Technology Transfer Seminar

Force Main Inspection & Assessment

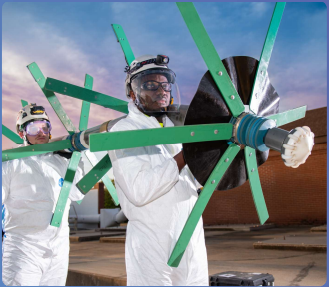
What is the PipeDiver Platform?

- Locating and quantifying *pipe wall distress* using electromagnetic technology
- Inspecting metallic and concrete force mains in a single deployment
- Collecting high-resolution data without shutdowns, dewatering, excavations, or extensive civil work
- Pairing with complementary Xylem services to support economic and proactive asset management

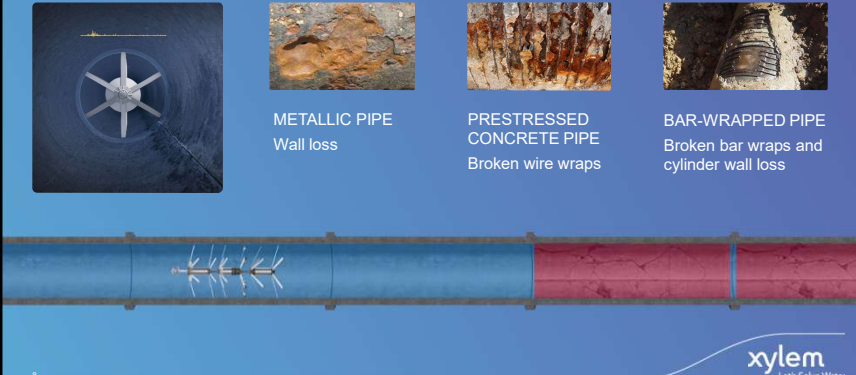
How Does the PipeDiver Platform Work?

METALLIC PIPE
Wall loss
-

PRESTRESSED CONCRETE PIPE
Broken wire wraps
-

BAR-WRAPPED PIPE
Broken bar wraps and cylinder wall loss

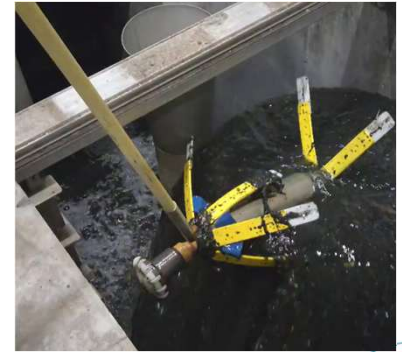
Inspection Execution

- Inspection run sequencing:
1. Ultrasonic platform
 2. Electromagnetic platform
 3. Electromagnetic platform

No precleaning/flushing completed
 Real-time tool tracking
 Significant ragging noted on Run 1
 • Ragging not observed in Run 2 or 3

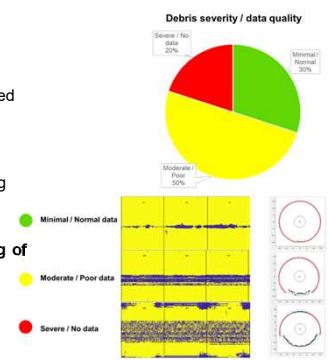
Ultrasonic Inspection Results

- Ultrasonic signal response not impeded by wastewater or encasement
- **Debris was the primary limiter;** effectively served as an initial cleaning pass
- **Profiling data aids in understanding of debris location and severity**

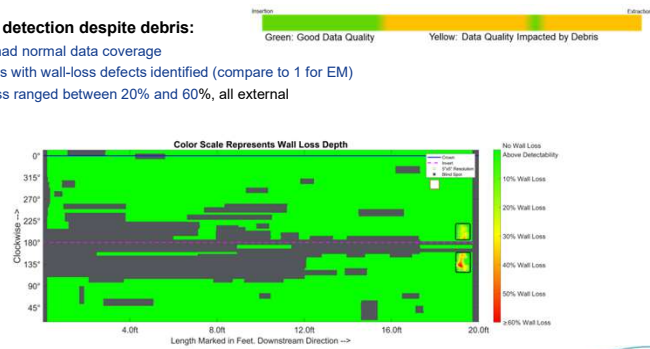
Ultrasonic Inspection Results

Wall loss detection despite debris:

- ~30% had normal data coverage
- 37 pipes with wall-loss defects identified (compare to 1 for EM)
- Wall loss ranged between 20% and 60%, all external
