SESSION II Collection System O&M

Long Range Sewer Cleaning Equipment, Jobs and Job Set Ups

PVSC Main Interceptor Sewer Cleaning, Contract B165A

National Water Main Cleaning Company

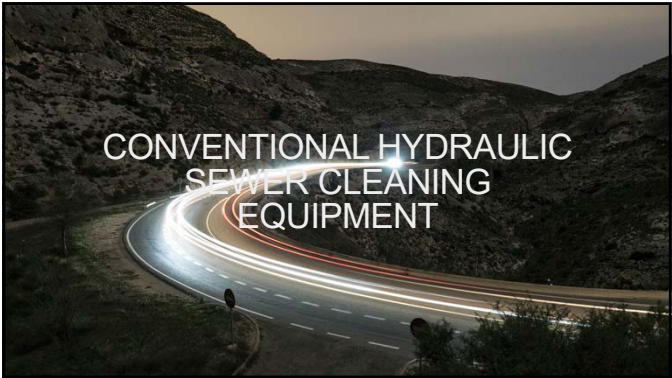
Combination CCTV/Sonar

Results of Sonar Inspection of a Half Full 120 inch Sewer

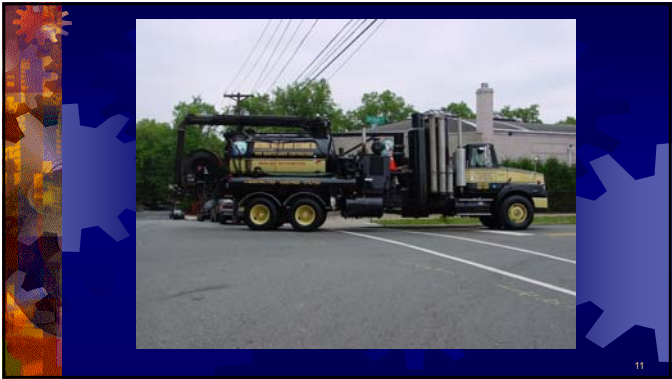
Combination CCTV/Sonar

SEDIMENT DATA			
Max grease on top:	Avg. Sediments on top:	Est. Sediments Vol. on top:	Blockage % on top:
0.0	0.0		
Max debris on bottom:	Avg. Sediments on bottom:	Est. Sediments Vol. on bottom:	Blockage % on bottom:
58.0	49.8	20,897.11 cu ft	39.6 %
Max debris sum:	Avg. Sediment sum:	Est. Sediment Vol. sum:	Total blockage %:
58.0	49.8	20,897.11 cu ft	39.6 %

Results of Sonar Inspection of a Half Full 120 inch Sewer – Approximately 775 Cubic Yards of Debris in less than 500 Feet of Pipes

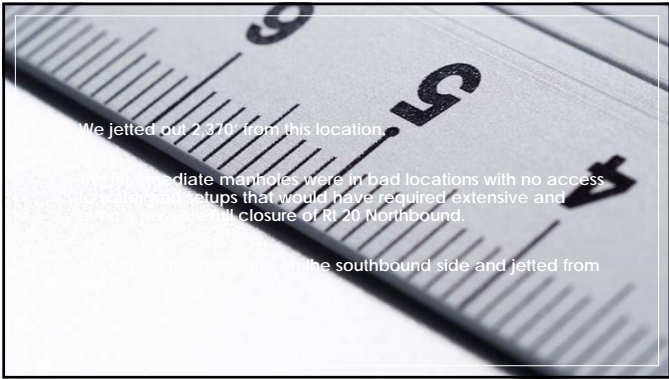
We jetted out 2,370' from this location.
The immediate manholes were in bad locations with no access
for jetting and setups that would have required extensive and
expensive road closures of Rt 20 Northbound.
We did a double lane closure on the southbound side and jetted from

Route 20 and Fairlawn Ave, Paterson, NJ
Setup on MH-198 for 25 days
35 tons of Debris
Double lane closure completed by MPI would have been \$4,098
per shift so figure a \$102,450 savings in traffic (we did our own
traffic here so did have some cost associated with it the setup
though.)
