# NJWEA - Winter Tech Transfer 2026 Cleaning and Inspection

## A Programmatic Approach to Sewer Screening

NJWEA WINTER TECHNOLOGY TRANSFER SEMINAR 2026

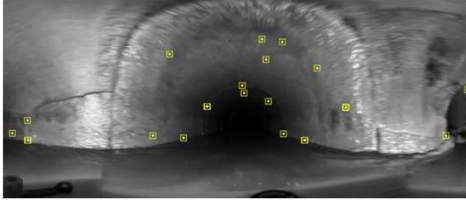
Using our Cloud platform, computer vision and AI, enables FlowSIGHT to automate processes and reduce or eliminate many manual tasks.

Type	Distance	Remarks
Major I&I	84.75 ft	Gusher
Video ref.	10

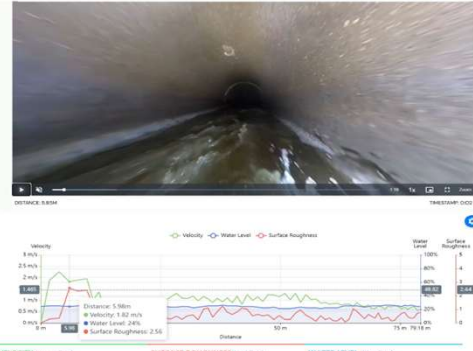
**LIVE CAPTURE: HYDRAULIC JUMP EVENT**

**WHAT IS THIS?**  
A hydraulic jump — flow transitions from supercritical ( $Fr > 1$ ) to subcritical ( $Fr < 1$ ). Excess kinetic energy dissipates as turbulence. The video captures the float passing through the jump; the graph quantifies the regime change at that exact location.

**WHY DOES IT MATTER?**  
Every hydraulic jump is energy that should be moving wastewater, but is lost to turbulence. A jump can also signal that the pipe's gradient or geometry has deviated from design.

Worse, the violent surface disruption strips dissolved  $H_2S$  into the headspace, initiating crown corrosion downstream. One hydraulic jump creates three compounding problems: energy loss, capacity loss, and an active corrosion zone hundreds of feet away and where CCTV would code the damage without ever identifying the upstream cause.

CMOM requires utilities to evaluate capacity, identify hydraulic limitations, and shift from reactive to preventive maintenance. A hydraulic jump is a direct, measurable indicator that the pipe's hydraulic performance has deviated from its design envelope. It is exactly the "early warning sign" the CMOM framework asks utilities to detect — and until now, they have had no mechanism to find it in large gravity sewers.

PACP has no defect code for a hydraulic jump. No code for "flow regime transition," no code for "energy dissipation event." Even if a CCTV crawler or float physically traversed this location, the unit itself occupies cross-sectional area and alters the flow regime — the jump may shift, change intensity, or

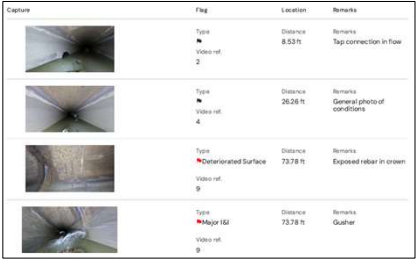
Capture	Flag	Location	Remarks
	Type: Video-ref: 2 Distance: 8.53 ft Remarks: Tap connection in flow		
	Type: Video-ref: 4 Distance: 26.26 ft Remarks: General photo of conditions		
	Type: Deteriorated Surface Video-ref: 9 Distance: 73.78 ft Remarks: Exposed rubber in stream		
	Type: Major ISI Video-ref: 9 Distance: 73.78 ft Remarks: Gutter

**Output: Red Flag Report (.pdf)**

**Output: Video Data (.mp4)**  
Segmented and Georeferenced

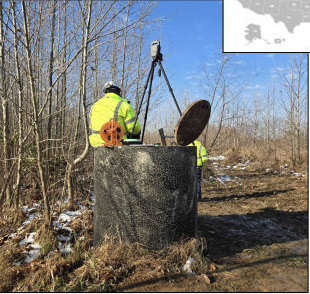
**Duckett Ck Sanitary District**

**Project Name: Confirmation Screening**

**Location: O'Fallon, MO**

- Access to the sewer was sensitive and difficult going through a community and farmland
- Conventional methods were not suited to the topography
- Challenging flow conditions

**Result**  
Condition was confirmed defective, and the decision was made to put out a multi-million dollar lining job.

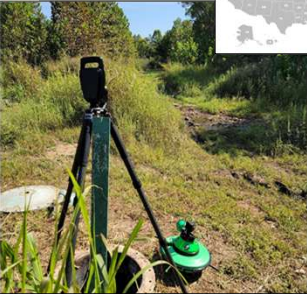
**Objective:**  
Client had a failure in a similar fiberglass pipe and needed to confirm integrity of 2 mile of critical pipe

- Because of the remote nature of the line, traditional inspection methodology could not be deployed.
- The versatility of the SewerScout allowed it to be transported to the location where it inspected 2 miles of fiberglass pipe.
- The entire deployment was completed in 2 hours.
- Good Bill of health – one small hole

**Result**  
Integrity for the 2 miles of pipe was confirmed onsite to be in a good state. Follow up report was delivered. One Defect Found
