New Jersey Water Environment Association Presents

SESSION II - Collection System O&M Sweet Solutions for Your Assets, Without Sugar Coating It!

**YANTACAW STREET
PARSHALL FLUME
WHY WE DIDN'T (SUGAR) COAT IT**

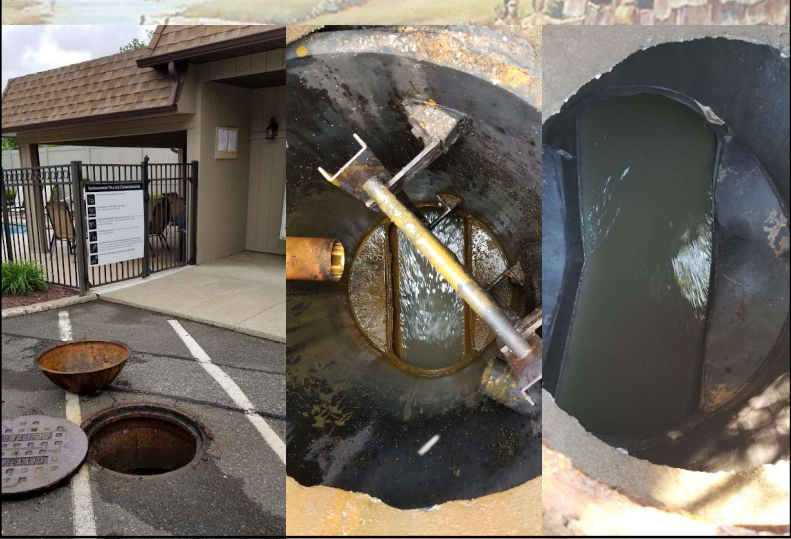
NO EVIDENCE OF SURCHARGING

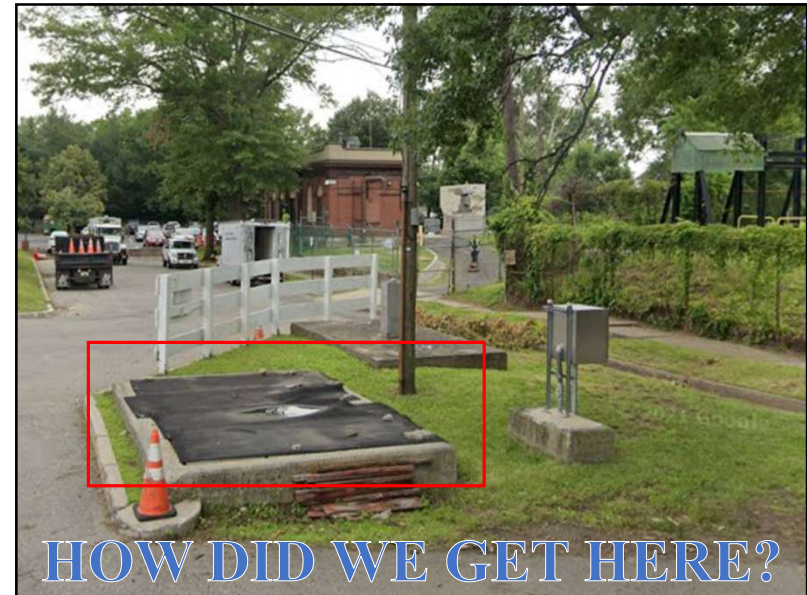
THE ORIGINAL ESR

- This 1foot Parshall Flume was constructed of concrete in the early 1980's. The surface has eroded to the point where aggregate is exposed in the channel and the surface is no longer smooth as required for accurate flow measurement.
- In recent years, the flow range has been scaled down to match the modern flow conditions which varies between 0.6 and 1.2 MGD. (See Chart) **We should explore resurfacing the flume to smooth and sealing with a protective coating.**
- Since the existing open grating and rubber mats contribute to the water entering the chamber from the surface, please consider replacing them with Bilco doors to mitigate rainwater's effect on the erosion and odors from the chamber.
